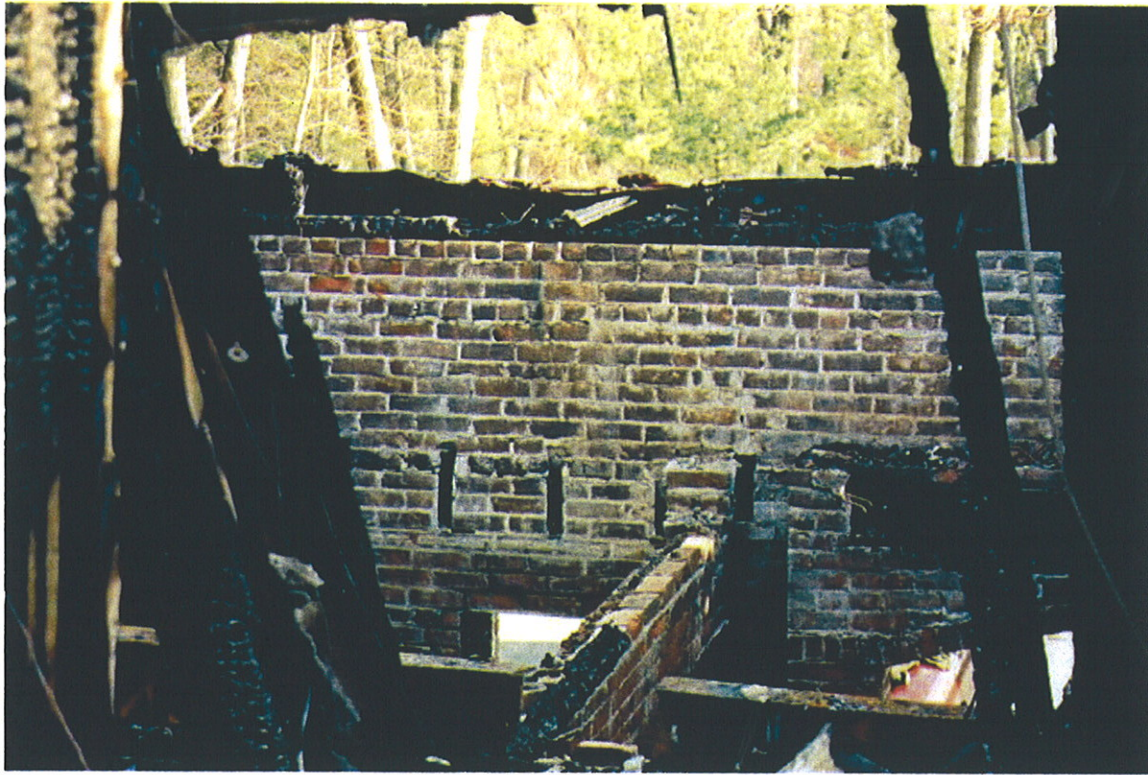
Photo 16: The combustible wall area/floor-ceiling area above the right hand portion of the kitchen. Note 2x12" floor joists were totally consumed in this area.

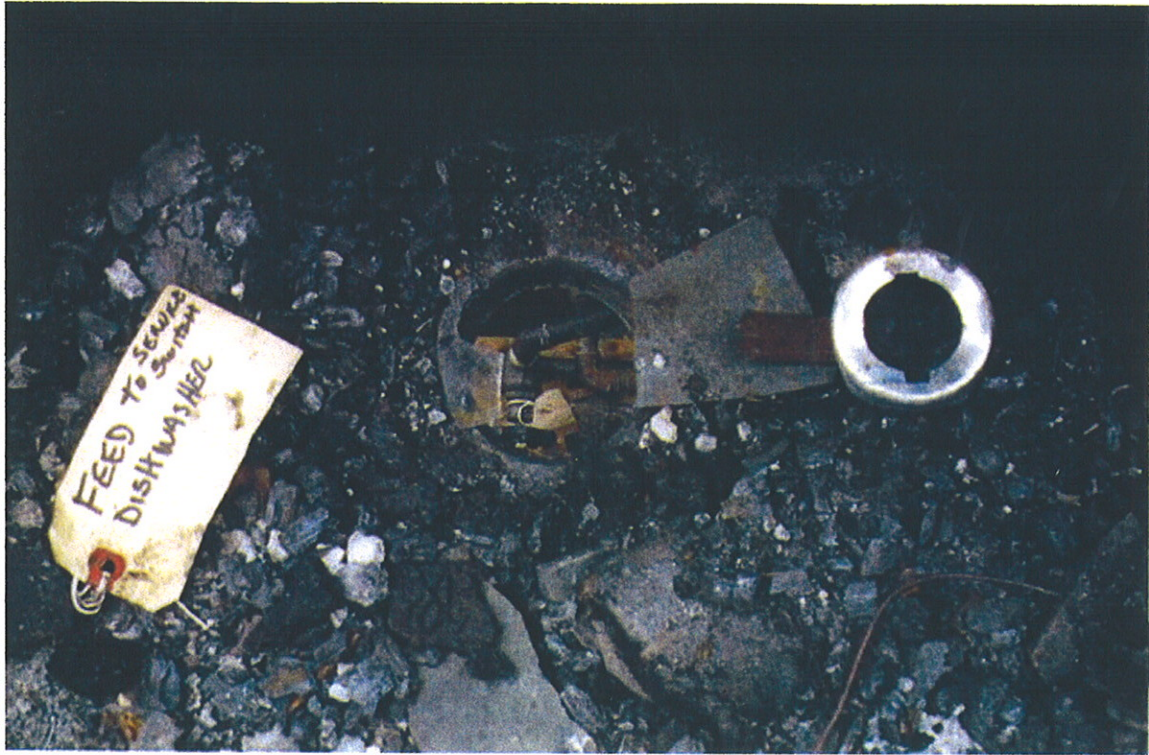
Photo 17: With sink in place (i.e. reconstruction) the extensiveness of piping modification is depicted.

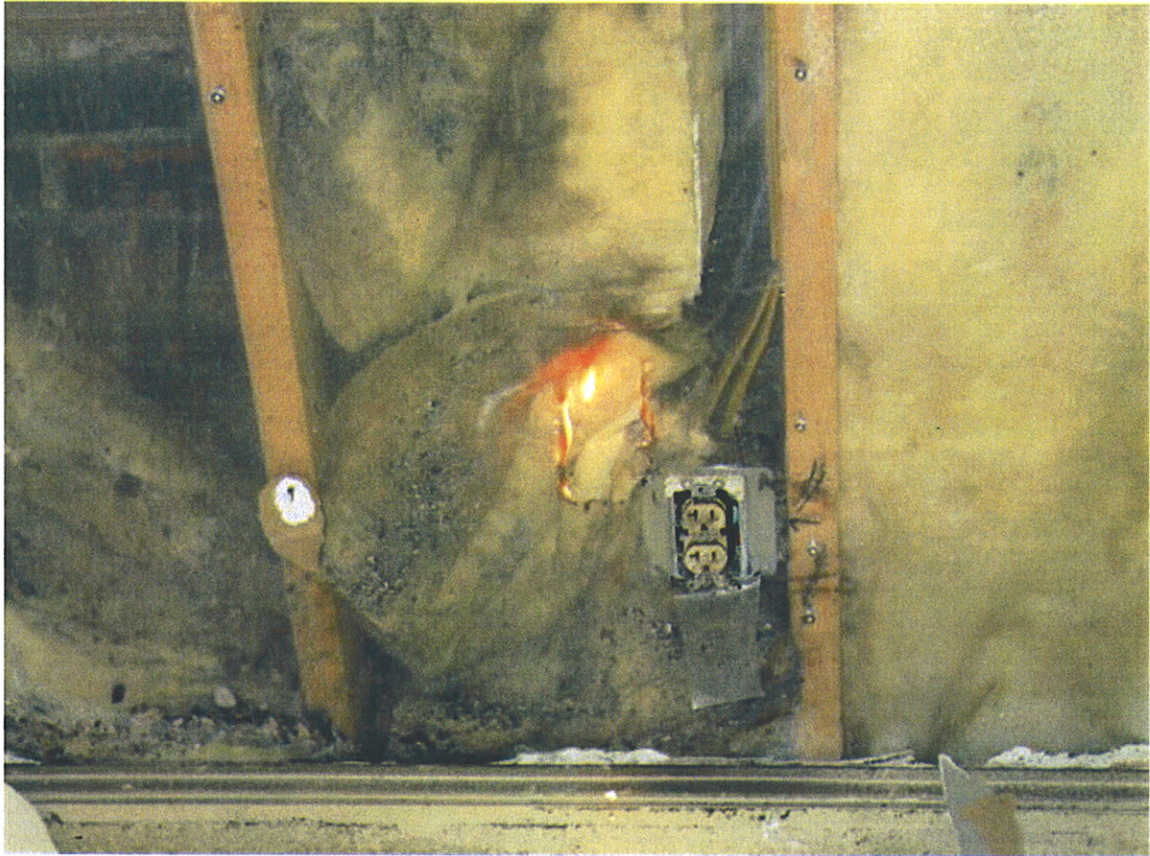
Photo 18: Demonstrative ease of ignition and rate of flame spread of polyethylene vapor barrier conducted within the carriage house.
